THAPAR INSTITUTE
OF ENGINEERING & TECHNOLOGY
(Deemed to be University)

Industrial Training

(Tata Motors India Pvt. Ltd.)

Reduction of DPH (by process)

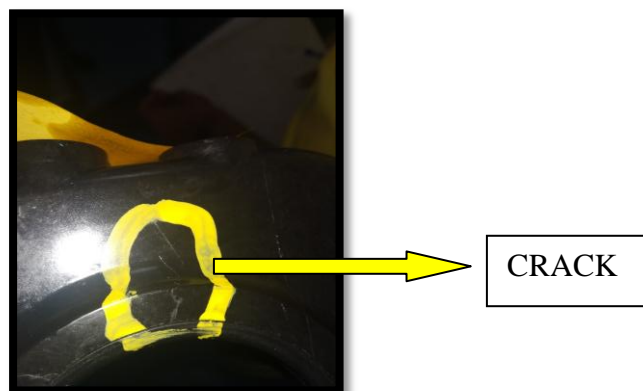
Figure 16, Head Cover Crack

What	What is the problem?	1. Head Cover Crack
	What has the problem? (part no, Lot no, etc.)	Cylinder Head Cover . Part no- 2788211501240
	What is the impact of the problem?	High value of DPH.
Where	Where is problem located on Product/Part?	It is located on the leftmost part where there is nose in the head cover
	Where does the problem occur in the process?	Problem is occurred during dome nut tightening using DCNR.
	Where was the problem observed in the process?	The problem is observed at the QG-1 (Quality Gate-1) in the 275 assembly line.
When	When was the problem first noticed?	The problem has been occurring since November (Start of my analysis)
	When has it been noticed since?	6 Months
Who	Who is affected by the problem?	Engine shop is affected by the problem as low targets achieved per day.
	Who First observed the problem?	Problem was first observed by the Engine Rework Area of the Powertrain.

To whom was the problem reported?	Problem was reported to the VQA (Vendor Quality Assurance) team of the powertrain.
How	How much is the problem?	Most common reason for the oilways leakage in the engine.
	How is the problem being rectified?	Replacement of the head cover in the engine.

In the assembly line engines are mounted on the J- Hook and it moves at each workstation. There is generally 0-5mm gap between the heights of these J hooks. The head cover tightening DCNR is installed at the fixed height and when it is to be used for tightening, it comes down to its fixed position. But there is the tolerance of 5 mm on the J- hooks. This distance is taken care by the spring on the each spindle of the DCNR so that its load is not transferred to the plastic head cover. If the load of DCNR is passed onto the head cover it cracks from its weakest end.

The springs used in the head cover tightening DCNR are already too compressed that they doesn't negate the 5 mm gap between the j-Hooks. Hence the complete DCNR load is transferred into the Head cover and it gets crack.

Therefore to correct the process, the initial compression of the spring needs to be 0. Therefore the DCNR spindles were taken out, the springs were detached, and then cut under the supervision so that the initial compression becomes 0. As a result the load of the DCNR is barred by the springs and the head cover doesn't gets crack.

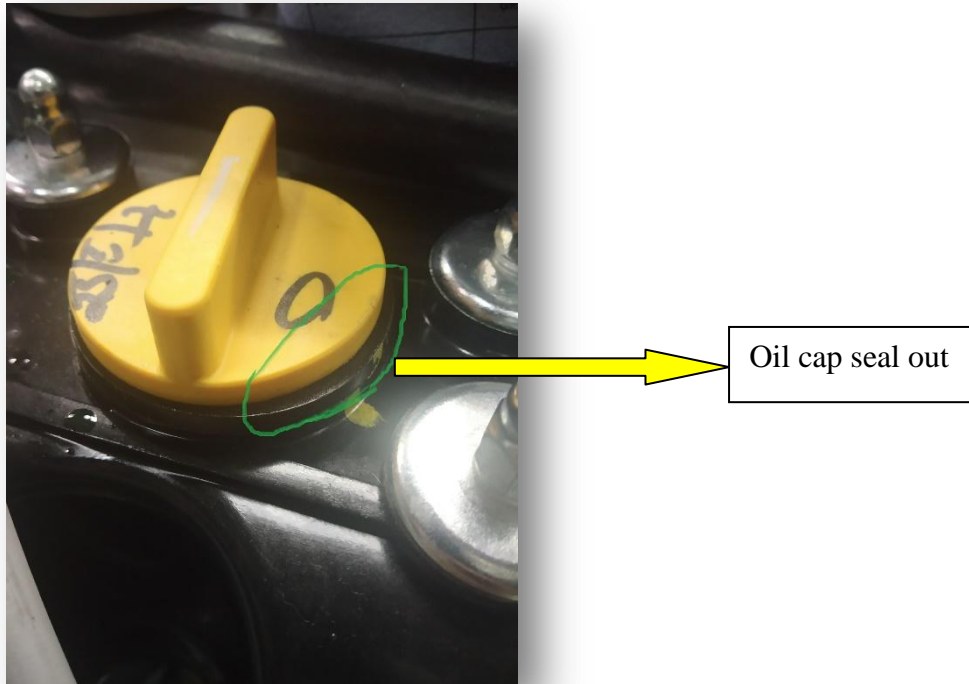
Figure 19, Oil cap seal out

Oil cap is placed on the head cover and is tightened after the oil is filled on the assembly line for the testing purposes. The leakages occur due to either the seal is loose or it is over tight. The oil seal is to be tightened with torque of 0.5 kg-m after the oil filling. If we apply torque less than 0.5 kg-m the oil cap will be loose. If we over tight i.e. apply torque more than 0.5 kg-m then seal from the oil cap comes out hence resulting in the leakage.

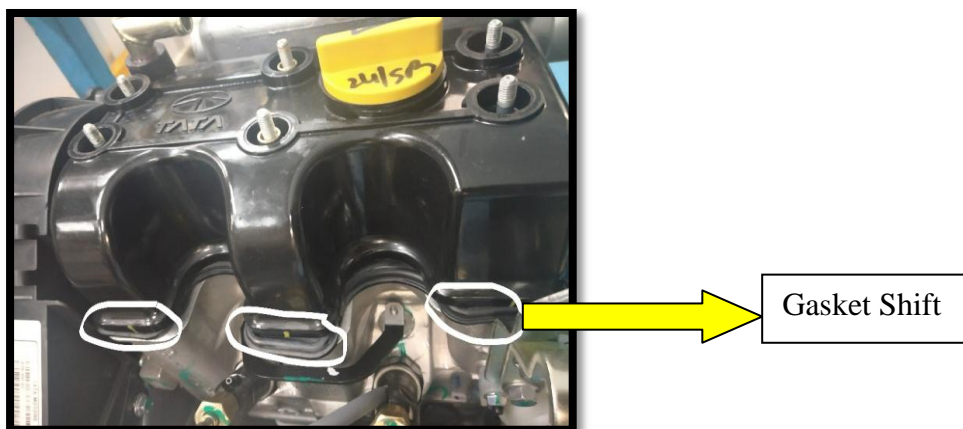
FIGURE 22, Gasket Shift

What	What is the problem?	3. Gasket shift during head cover fitment
	What has the problem? (part no, Lot no, etc.)	Cylinder Head Cover . Part no- 2788211501240
	What is the impact of the problem?	High value of DPH.
Where	Where is problem located on Product/Part?	Gasket is placed in the bottom of the head cover and is placed is fitted in the grooves.
	Where does the problem occur in the process?	Problem is occurred during fitment of head cover in the engine.
	Where was the problem observed in the process?	The problem is observed at the QG-1 (Quality Gate-1) .
When	When was the problem first noticed?	The problem has been occurring since November (Start of my analysis)
	When has it been noticed since?	6 Months
Who	Who is affected by the problem?	Engine shop is affected by the problem as low targets achieved per day.
	Who First observed the problem?	Problem was first observed by the Engine Rework Area of the Powertrain.

During the fitment of head cover gasket by the vendor, it is inserted in the grooves at the bottom of the head cover. There is no type of sealant used to bind the head cover and the gasket together. So there are possibly 2 methods to reduce the cases of the gasket failure-

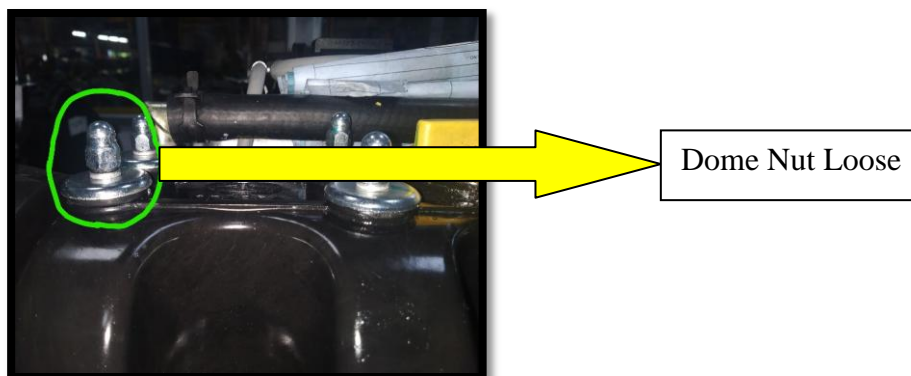
Figure 25, Dome Nut Loose

What	What is the problem?	4. Dome Nuts Loose
	What has the problem? (part no, Lot no, etc.)	Cylinder Head Cover . Part no- 2788211501240
	What is the impact of the problem?	High value of DPH.
Where	Where is problem located on Product/Part?	Dome Nuts are Used for tightening of the Head cover.
	Where does the problem occur in the process?	Problem is occurred during tightening of the head cover.
	Where was the problem observed in the process?	The problem is observed at the QG-1 (Quality Gate-1) .
When	When was the problem first noticed?	The problem has been occurring since November (Start of my analysis)
	When has it been noticed since?	6 Months
Who	Who is affected by the problem?	Engine shop is affected by the problem as low targets achieved per day.
	Who First observed the problem?	Problem was first observed by the Engine Rework Area of the Powertrain.
	To whom was the problem reported?	Problem was reported to the line in charge of the assembly line.

The dome nuts are tightened on the head cover by the multi spindle DCNR i.e. Direct Current Nut runner. As the J-Hook is moving there can be misalignment in the DCNR at the time of tightening. Though there is display system on the DCNR if all the nuts are tightened properly but sometimes the operator ignores that. As a result some of the dome nuts may remain loose and hence cause leakage.

To tackle the situation describe above a new process has been imposed on the line that after the DCNR tightens the dome nuts, the operator has to manually check each of the 6 dome nuts using the click type torque wrench and do the confirmatory marking thereafter.

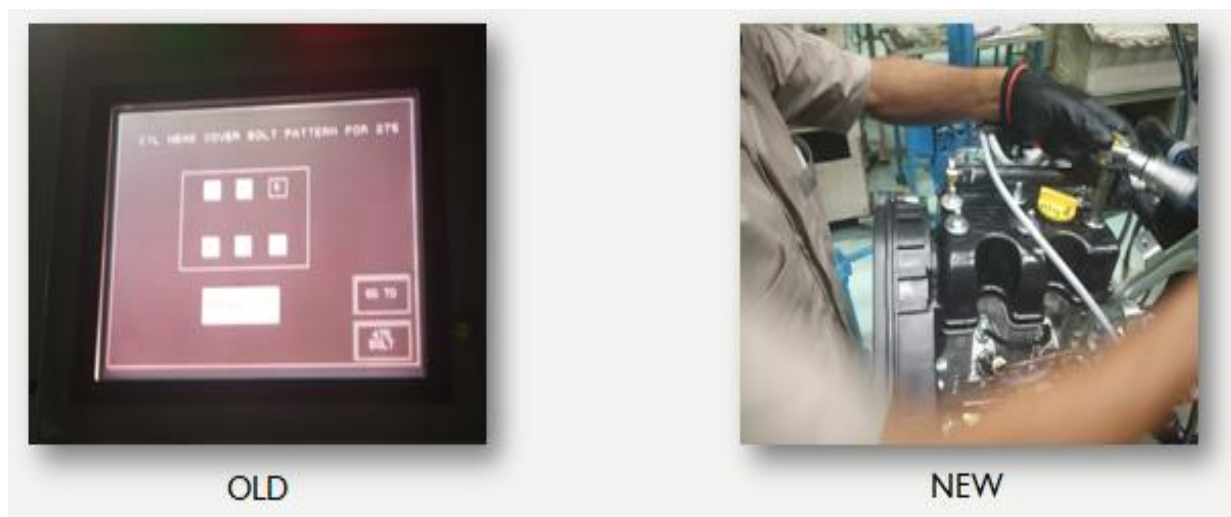
Figure 27, Action Plan Dome Nut tightening

As shown in the above picture the 3rd nut (top right dome nut) remained loose as the used spindle was misaligned during dome nut tightening using the DCNR.

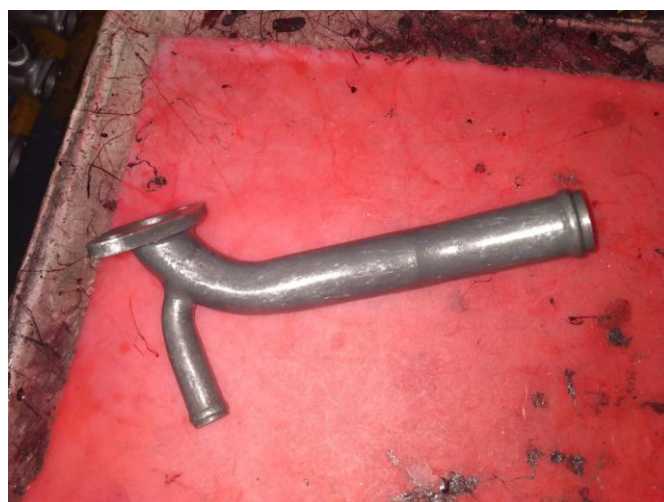
Figure 29, By pass tube

What	What is the problem?	1. Roughness on the Surface
	What has the problem? (part no, Lot no, etc.)	Water by pass tube
	What is the impact of the problem?	High value of DPH.
Where	Where is problem located on Product/Part?	Surface of the water by pass tube
	Where does the problem occur in the process?	Problem is occurred during assembly
	Where was the problem observed in the process?	The problem is observed at the QG-1 (Quality Gate-1) .
When	When was the problem first noticed?	The problem has been occurring since November (Start of my analysis)
	When has it been noticed since?	6 Months
Who	Who is affected by the problem?	Engine shop is affected by the problem as low targets achieved per day.
	Who First observed the problem?	Problem was first observed by the Engine Rework Area of the Powertrain.
	To whom was the problem reported?	The problem was reported to the VQA dept.
How	How much is the problem?	Problem is quite common and results in low targets achieved

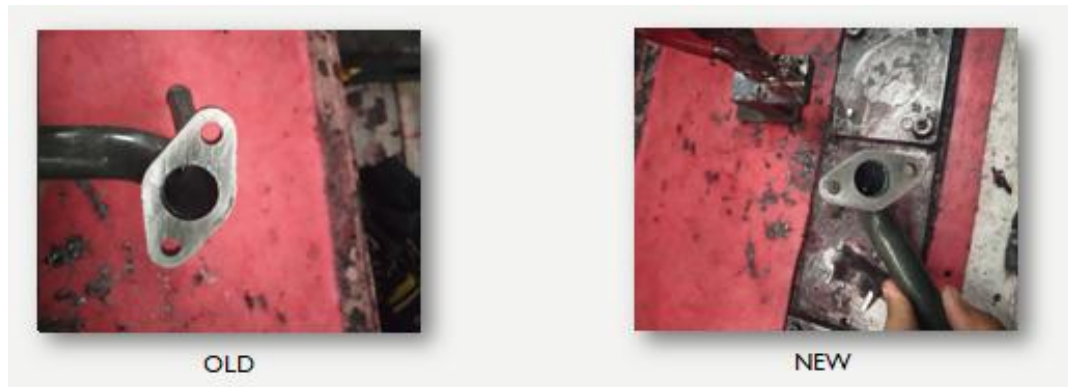
Figure 31, Bypass tube dent

Metal to metal contact can cause the dent on the water by pass tube. The dent may be caused during the transportation or the 275 IDI parts store in the power train shop. In case of the defect due to the dent on the surface, the problem is reported to the VQA team for the further assessment. If the problem is repeated from the vendor side then the vendor is informed and hence the problem is rectified.

Even the small roughness on the pipe can cause the leakage from the engine.

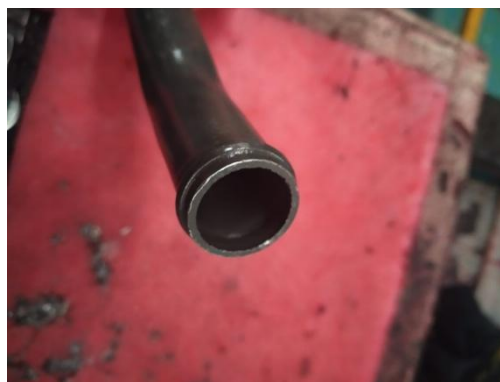
Figure 32, Ovality

This is the problem from the vendor, thus the VQA team was informed and hence it was rectified. There was no problem in the process. This problem had the major impact on the leakage and is thus mentioned in the report.

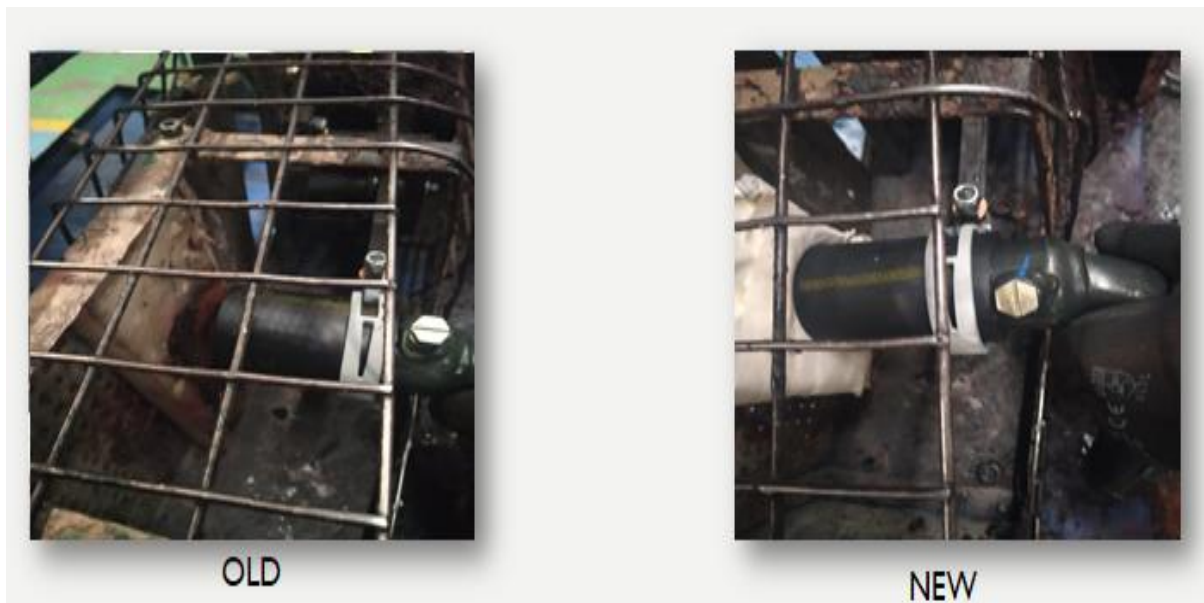
Figure 41, Clamp machine calibration

The clamp fixing machine is used to connect the hose pipe and the UCL in the sub assembly. There are 2 hose pipes installed on the each side of the UCL. The hose pipe and the UCL are attached in the sub assembly. The other part of the UCL is attached on the engine through the 2nd hose pipe. Clamps are used to fix the hose pipe and the UCL. There are usually markings on the hose pipes to assist the operators to fix the clamp in between the markings. But there are no markings on the hose pipes connected through the hose pipe. Hence, the hose pipe and the UCL are connected with the clamps with a 5 mm gap. There is no method to maintain the 5 mm gap on the assembly lines so there might be the leakage. But on the sub assembly there is a machine which helps maintaining the 5mm gaps. Firstly the clamp is fixed on the 2 tongs of the machine. Then the hose pipe dipped in anabond and attached with the UCL is passed through the clamp till it touches the padding. The thickness of padding is in such a way that when the pipe touches the padding, there is a 5mm gap between the clamp and the hose pipe. But there is a problem in the padding. The padding is a bit thin and the hose pipe cannot touch it. Hence the operator is maintaining the 5 mm gap just by guess. Hence the padding was to be increased to maintain the gap. On measuring the padding was found to be 7 mm thinner than the design. Hence the padding was removed and hence the accurate gap of 5 mm was maintained between the clamp and the hose pipe.
